NASA Helps Keep the Light Burning for the Saturn Car Company

NASA Stennis Space Center
Sept. 13, 2001
Success Story #2400492

NASA Helps Saturn Car Company with Hood Lamp Problem

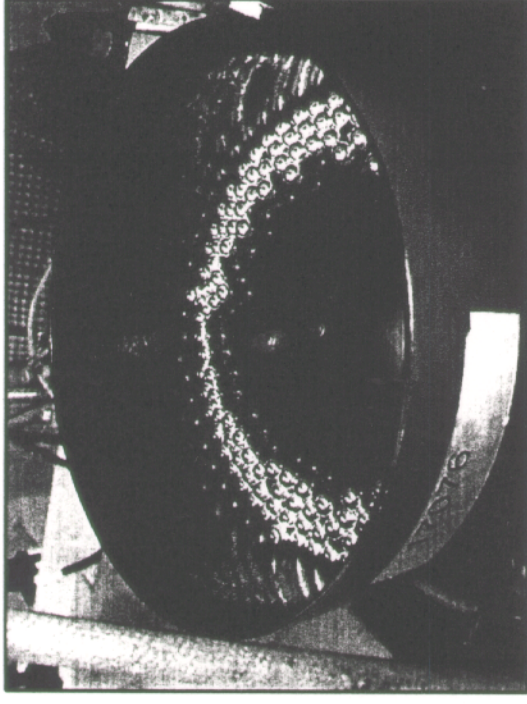
Cleaning materials and concentric wear of silver balls caused a leaching effect of the carbon-based liner within the hopper, thus causing a carbon build-up on the ball bearings and intermittent failures in the under-hood lamps.

NASA recommended that Saturn remove the liner coating from the hopper bowl and reduce the load size of silver-plated balls placed in the hopper. Fewer balls in the hopper bowl will reduce surface-wear due to less pressure exerted on the balls at the bottom of the hopper.

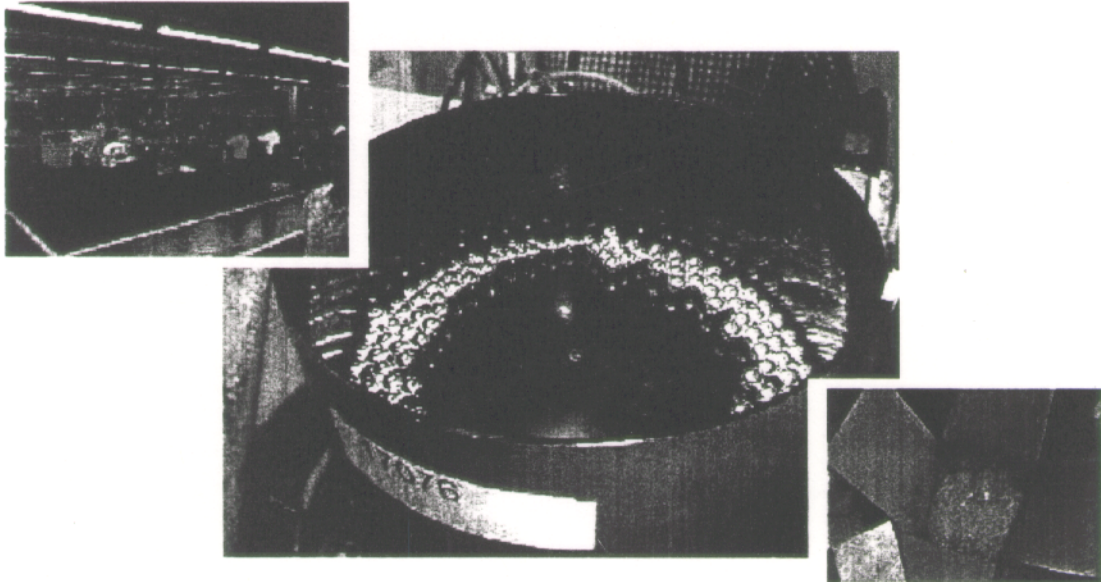
NASA identified the urethane coating on the hopper, center, contained 1 percent carbon that created buildup on the ball bearings, right, resulting in lamp failures.

NASA lab researchers determined the hopper bowl was lined with a urethane coating containing 1 percent carbon. The rotation and agitation of the silver-plated balls caused concentric rings of wear within the hopper coating. In addition, the cleaning materials used on the hopper caused a leaching effect of the coating, which also released carbon particles.

These particles then lodged onto the surface of the silver-plated balls through the pressures exerted from the multiple layers of balls in the hopper. The level of carbon contaminants would vary for each ball depending on the amount of contact with the liner surface area the ball encountered – this caused intermittent failures in the final lamp assemblies at an unpredictable rate.

NASA recommended that Saturn remove the liner coating from the hopper bowl and reduce the load size of silver-plated balls placed in the hopper. Fewer balls in the hopper bowl will reduce surface-wear due to less pressure exerted on the balls at the bottom of the hopper.
